# NATIONAL TRANSPORTATION SAFETY BOARD

## SPECIAL INVESTIGATION REPORT

STEAM LOCOMOTIVE FIREBOX EXPLOSION  
ON THE GETTYSBURG RAILROAD  
NEAR GARDNERS, PENNSYLVANIA  
JUNE 16, 1995

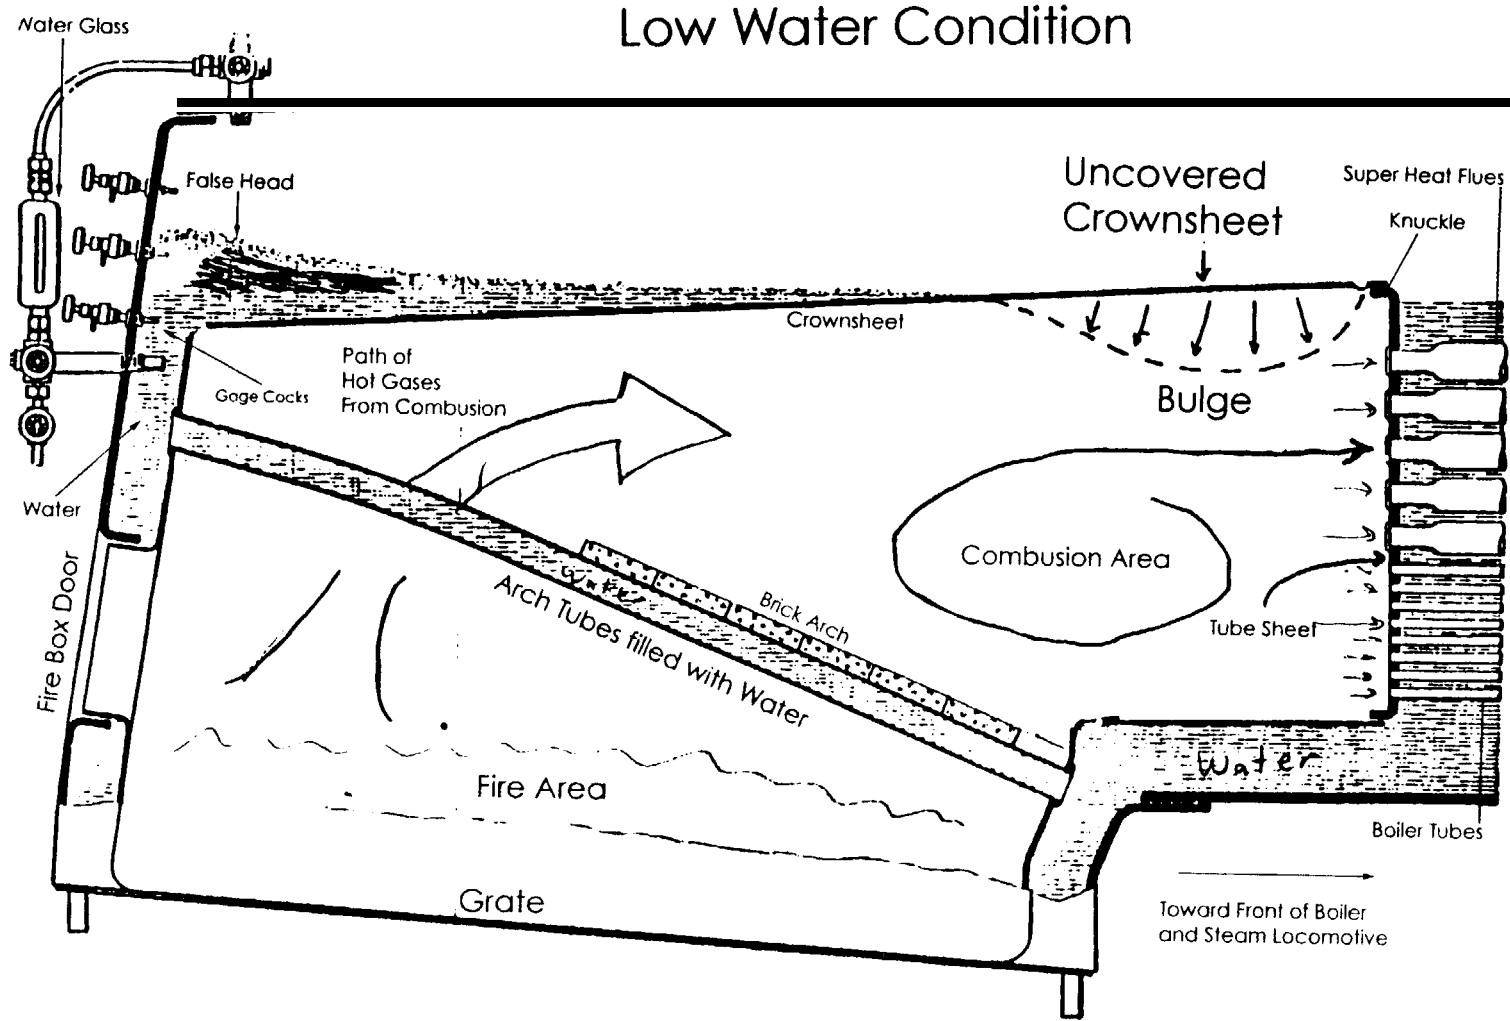
Figure 3. Firebox.

A postaccident inspection of locomotive 1278 revealed that the firebox was the only area to sustain major damage. (See figures 2, 3, and 4.) The crown sheet toward the front of the locomotive next to the rear tube-sheet knuckle<sup>11</sup> had bulged downward a maximum of about a foot in a "bag" shape that covered an area encompassing about 60 crown stays. The crown sheet holes around the crown stays had been deformed and elongated, creating gaps about the crown-stay heads. The crown sheet knuckle next to the flue sheet had a 6-inch tear. Also, two front (near the flue sheet) right firebox grate panels of the firebox floor had broken and fallen onto the ashpan below.

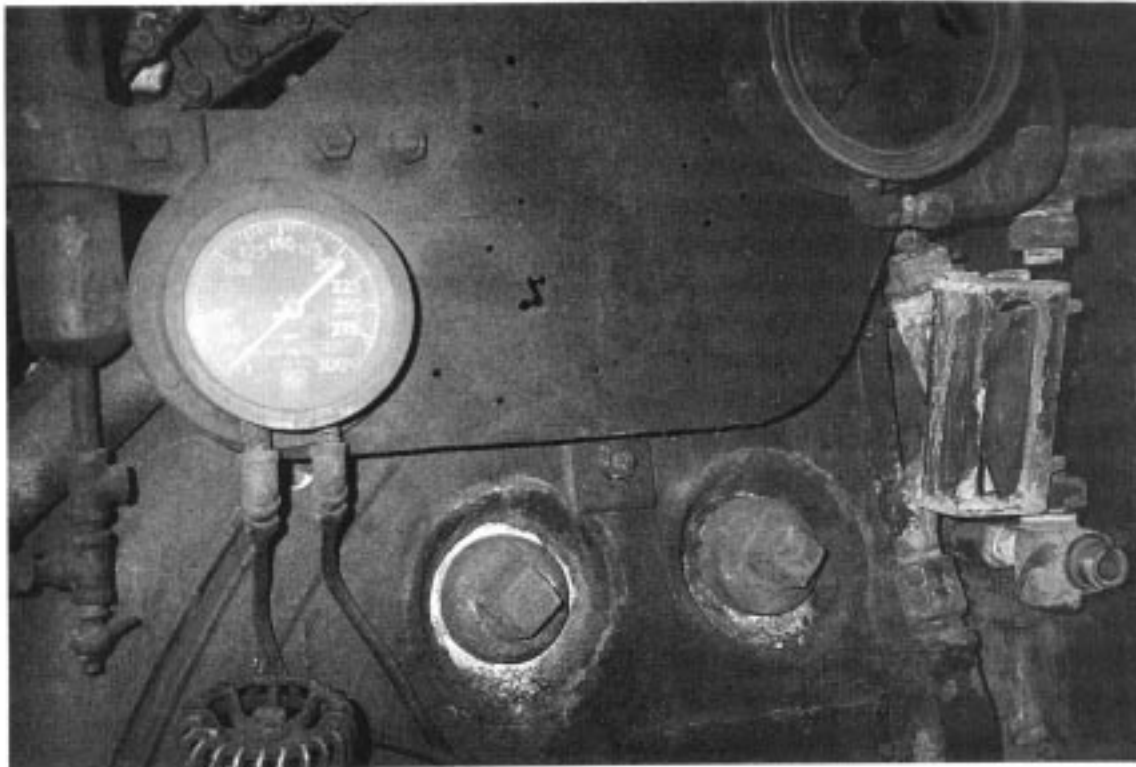
Figure 9. Missing gauges.

The engineer told Safety Board investigators that he removed the original feed-pump gage after it failed and that when the replacement also failed, he had decided not to replace it.

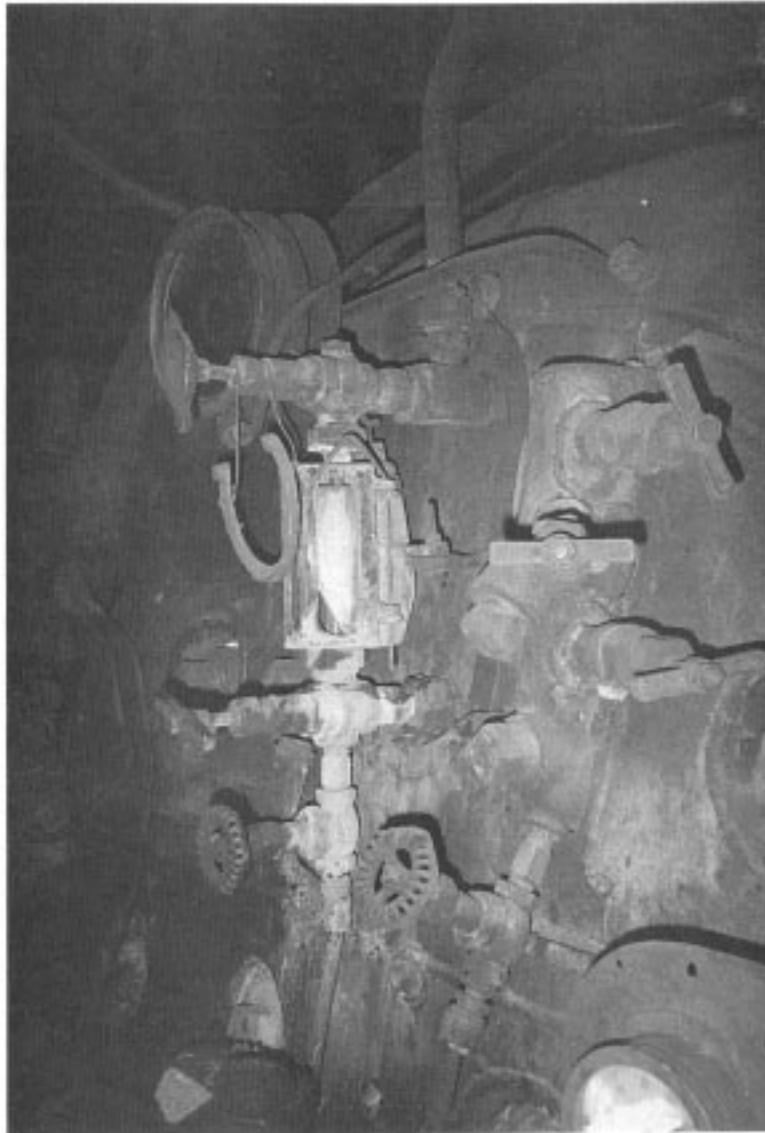
**Figure 11. Water glass after accident.**

The investigators removed and inspected the two valves, or shutoff cocks, (top and bottom) that connected the water glass to the boiler, as well as the water-glass drain cock. This assembly included the two spindles that go through the boiler shell. According to FRA requirements, "all water glasses must be blown out and gage cocks tested before each trip and maintained in such a condition that they can be easily opened and closed by hand without the aid of a wrench or other

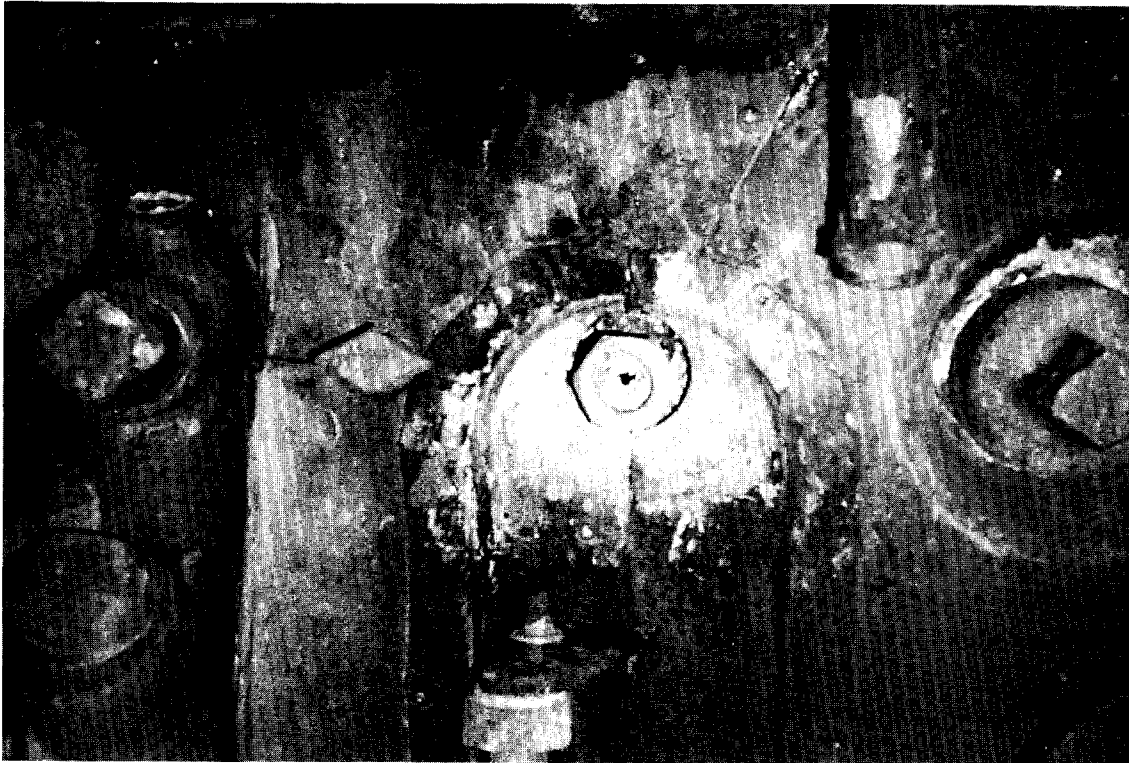
**Figure 12. End view of plugged spindle.**

tool." Also "the spindles of all gage cocks and water-glass cocks shall be removed and cocks thoroughly cleaned of scale and sediment at least once a month" (49 CFR 230.40 and .39, respectively). After the accident, the passages had significant deposits. The water-glass spindles were 75 to 85 percent plugged by hard scale. The investigators could not determine how much, if any, soft deposit or scale had been blown out during the explosion. (See figure 12.)

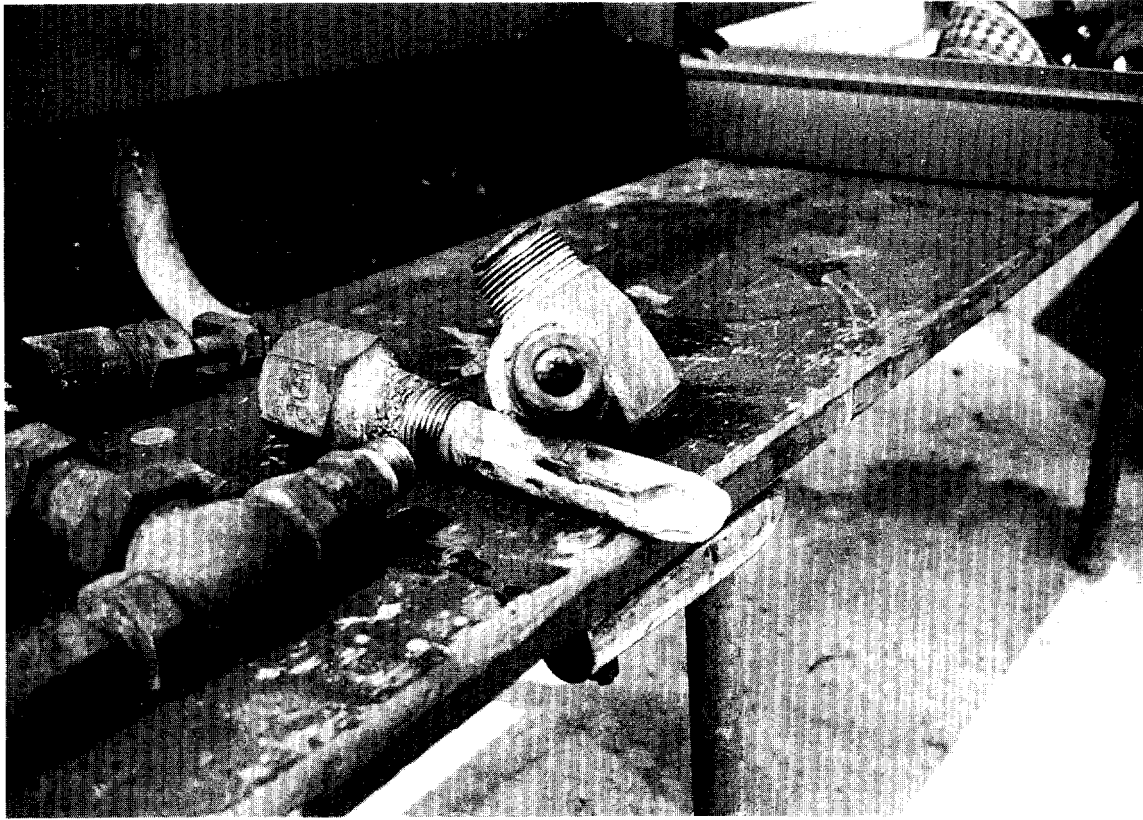
**Figure 13. Plugged spindle after removal.**

According to the regulations, the boiler must be washed once a month and the spindles must be reamed. When asked if the amount of scale found in the spindles could have accumulated between monthly cleanings, one steam-locomotive expert said, "No, no possible way." Another said, "I have never seen a locomotive that had as much scale inside the water-glass spindle as the 1278. I worked on a lot of locomotives all over the country and never saw anything like this." The chief mechanical officer (CMO) of the Strasburg Railroad speculated that in such a restricted condition, the spindles would be much more susceptible to being blocked by floating material or scale flake. The investigators were unanimous in their conviction that the amount of scale found in the spindles could not possibly have accumulated within the relatively short time between monthly boiler washings,

regardless of the condition of the water used. (See figure 13.)

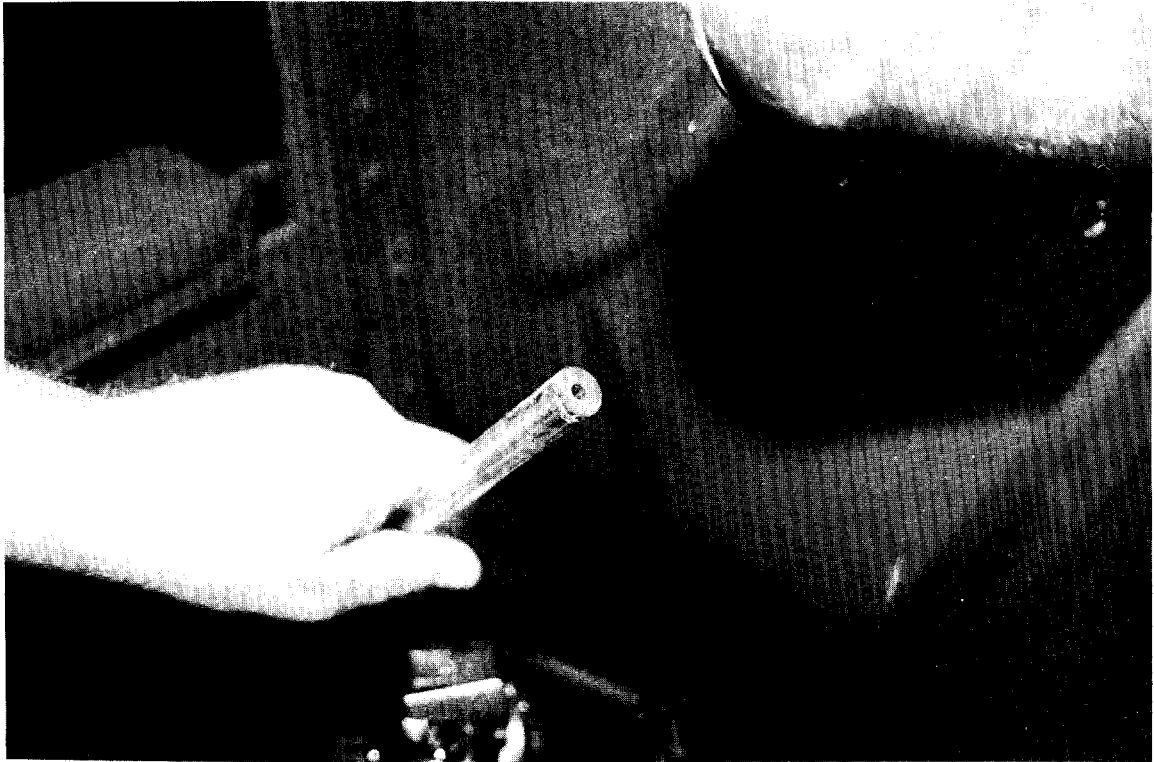
**Figure 14. Water-glass tube.**

The water glass itself was a glass tube about 12 inches long and 1/2 inch in diameter. Running the length of the glass was a 1/4-inch-wide faded red background line that was barely visible. The diameter of the bore (about 1/8 inch) appeared smaller than the 3/8-inch bore with which the inspectors were more familiar. They considered whether a smaller bore would be more susceptible to some form of capillary action or to being plugged by loose scale (either of which could yield a false reading). However, after they examined and tested the glass, they decided the diameter of the bore was acceptable. (See figure 14.)
