# NATIONAL TRANSPORTATION SAFETY BOARD

## SPECIAL INVESTIGATION REPORT

STEAM LOCOMOTIVE FIREBOX EXPLOSION  
ON THE GETTYSBURG RAILROAD  
NEAR GARDNERS, PENNSYLVANIA  
JUNE 16, 1995

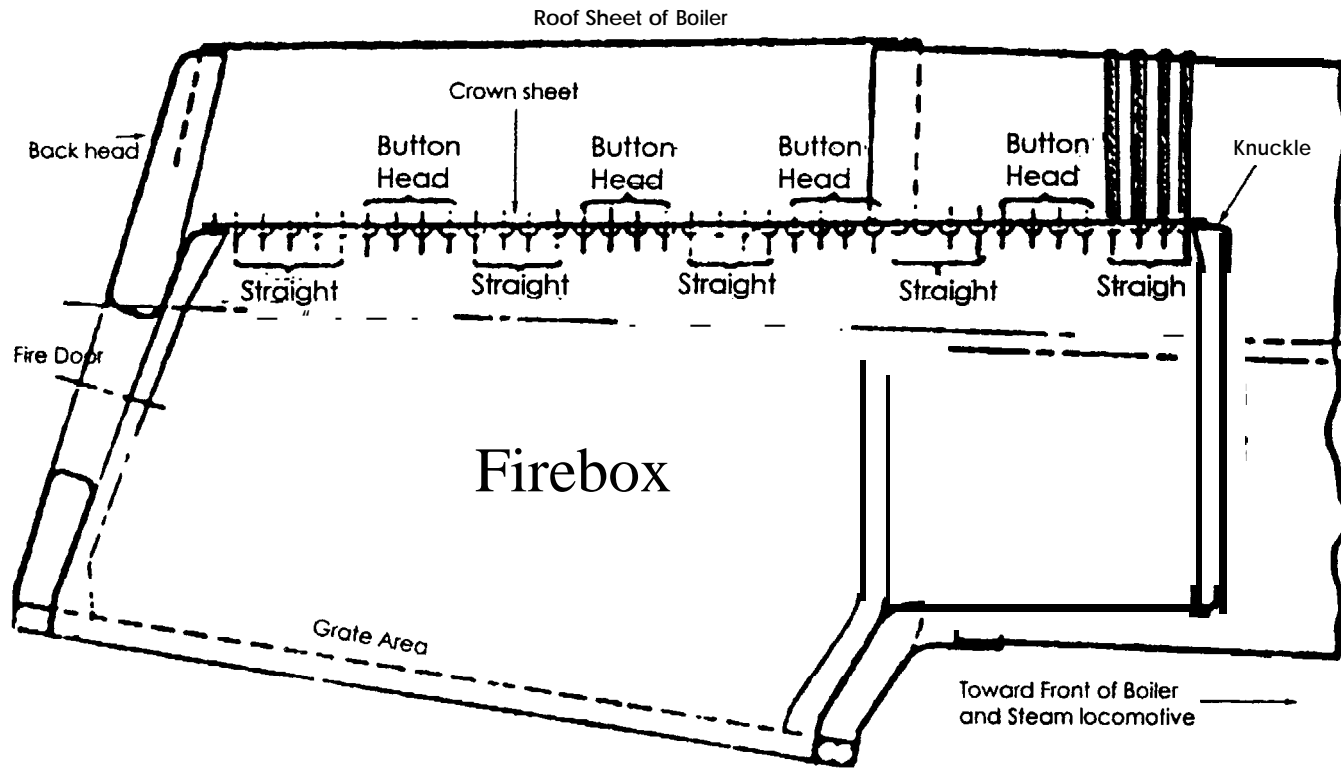
Figure 7. Alternating pattern of stays.

In accordance with Canadian Pacific policy, the crown stays, which supported the crownsheet from the boiler roof sheet,<sup>19</sup> were alternating rows of straight-thread and button-head crown stays. (See figures 6 and 7.) The first five rows from the rear tube-sheet knuckle (next to the tubes and flues) were straight-thread crown stays followed by rows of button-head crown stays. The boiler had been made that way so that if the crownsheet failed because it was not covered by water, it would be pushed off the straight-thread crown stays first. Consequently, although the crownsheet would buckle, it would be retained for a time by the button-head crown stays. Thus, if the crownsheet failed because of too little water, the failure would occur progressively and in stages, rather than instantaneously and catastrophically.<sup>20</sup> Other than being designed to make a failure a progressive, rather than an instantaneous, event, the boiler did not have any low-water protection devices.

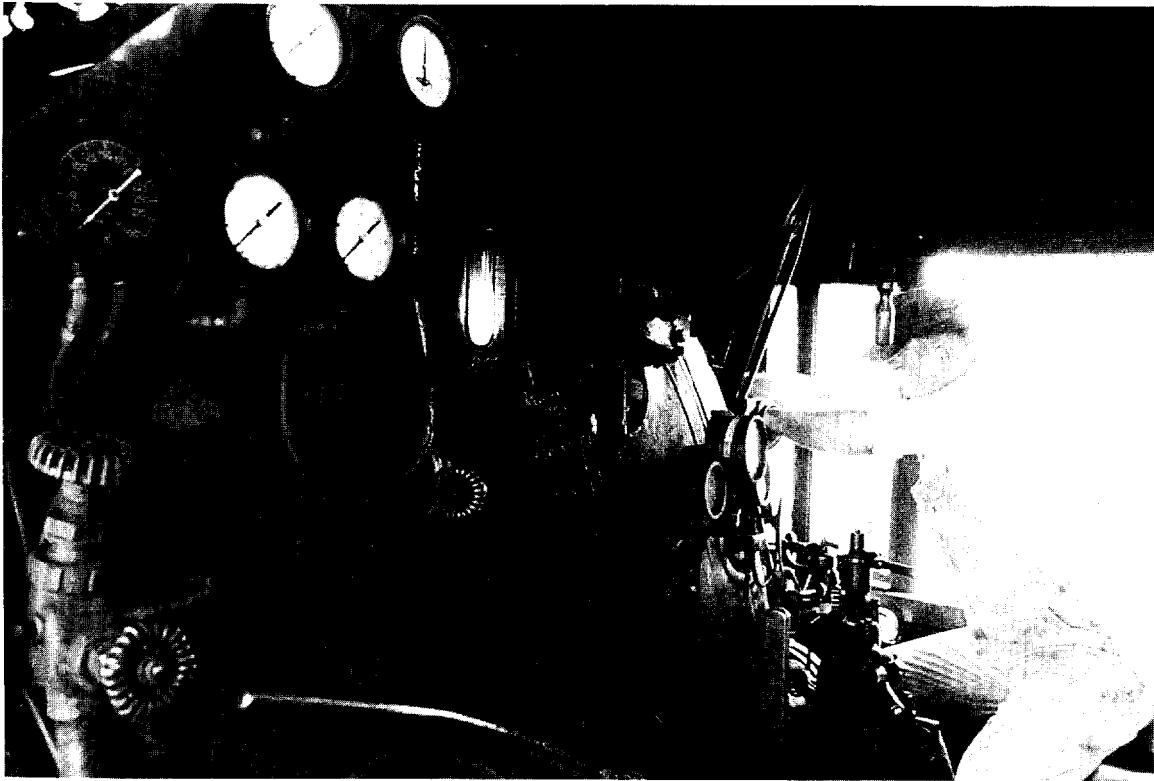
**Figure 8. Backhead.**

of the boiler.<sup>21</sup> (See figure 8.) A number of devices, including gages and the water glass, were mounted on the backhead. The backhead was also the location of the back of the firebox and the firebox door. Below the firebox door was the automatic stoker-auger entrance used to deliver coal to the firebox. The backhead had a number of washout plugs.<sup>22</sup> The engineer's seat was to the right side of the boiler and slightly to the rear of the backhead. Similarly, the fireman's seat was along the left side of the boiler.
